Land and Water

COLORADO CREEK RESTORED
for fishery enhancement

Restoring a Colorado Spring Creek for Fishery Enhancement

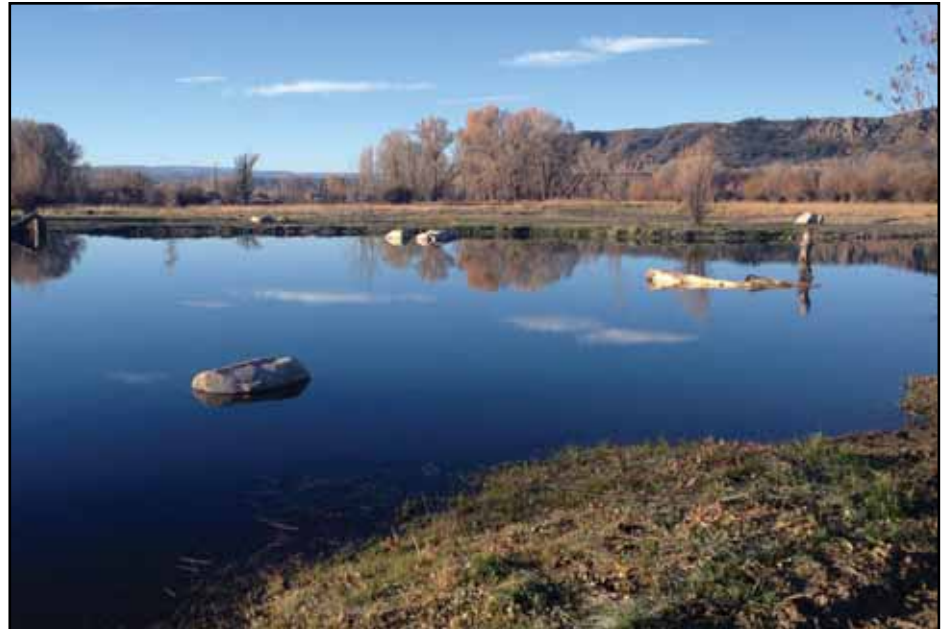
This is one of two ponds created on the spring creek. This pond is about 8 feet max depth and has littoral zones for beneficial aquatic macrophytes (plants), submerged logs and boulders. These ponds are intended to be fisheries and to be used by local waterfowl.

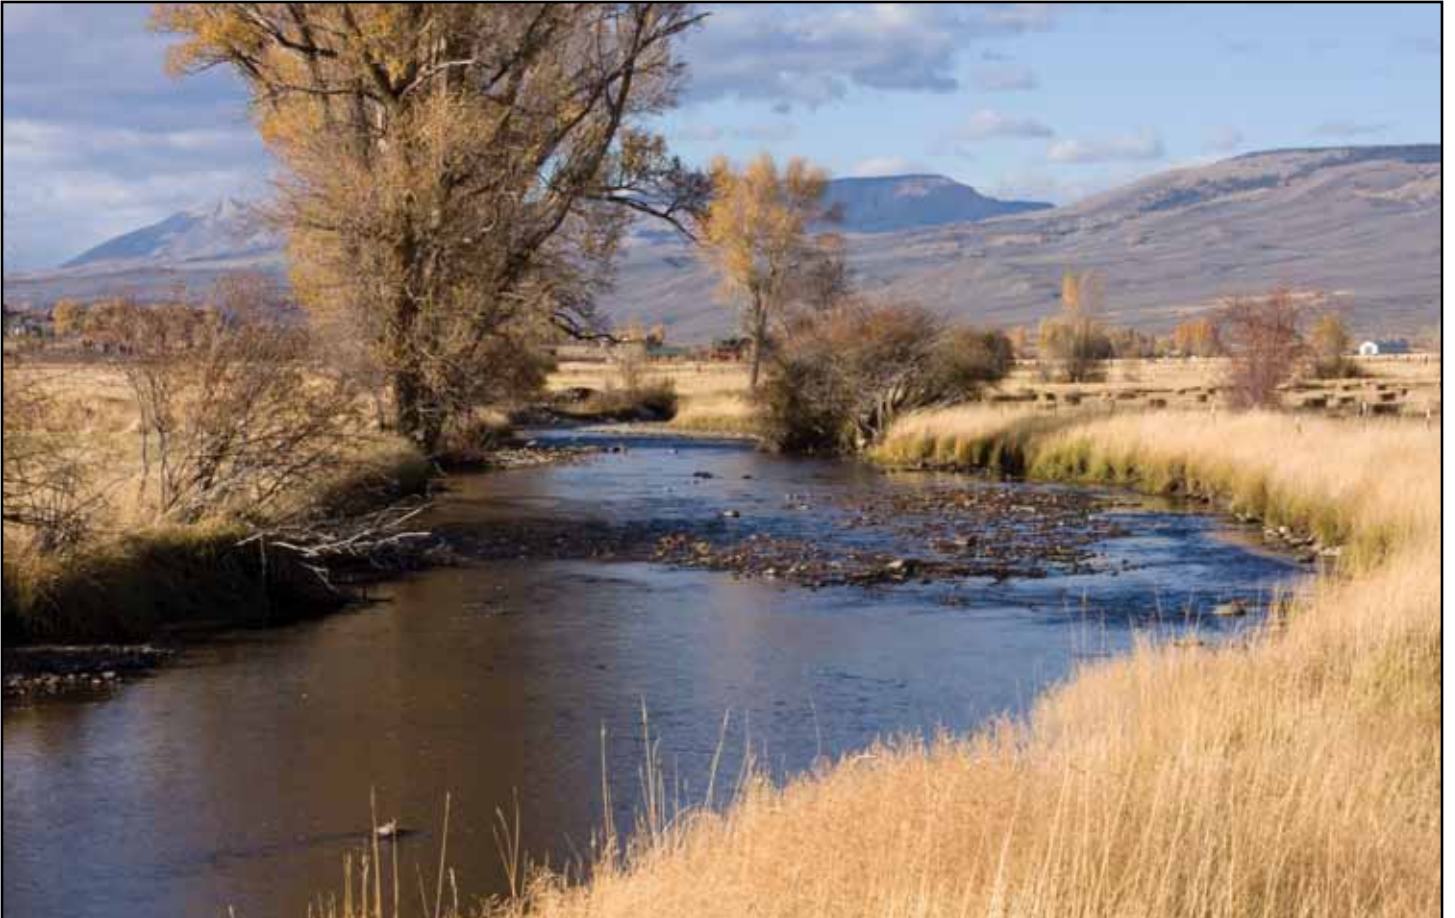
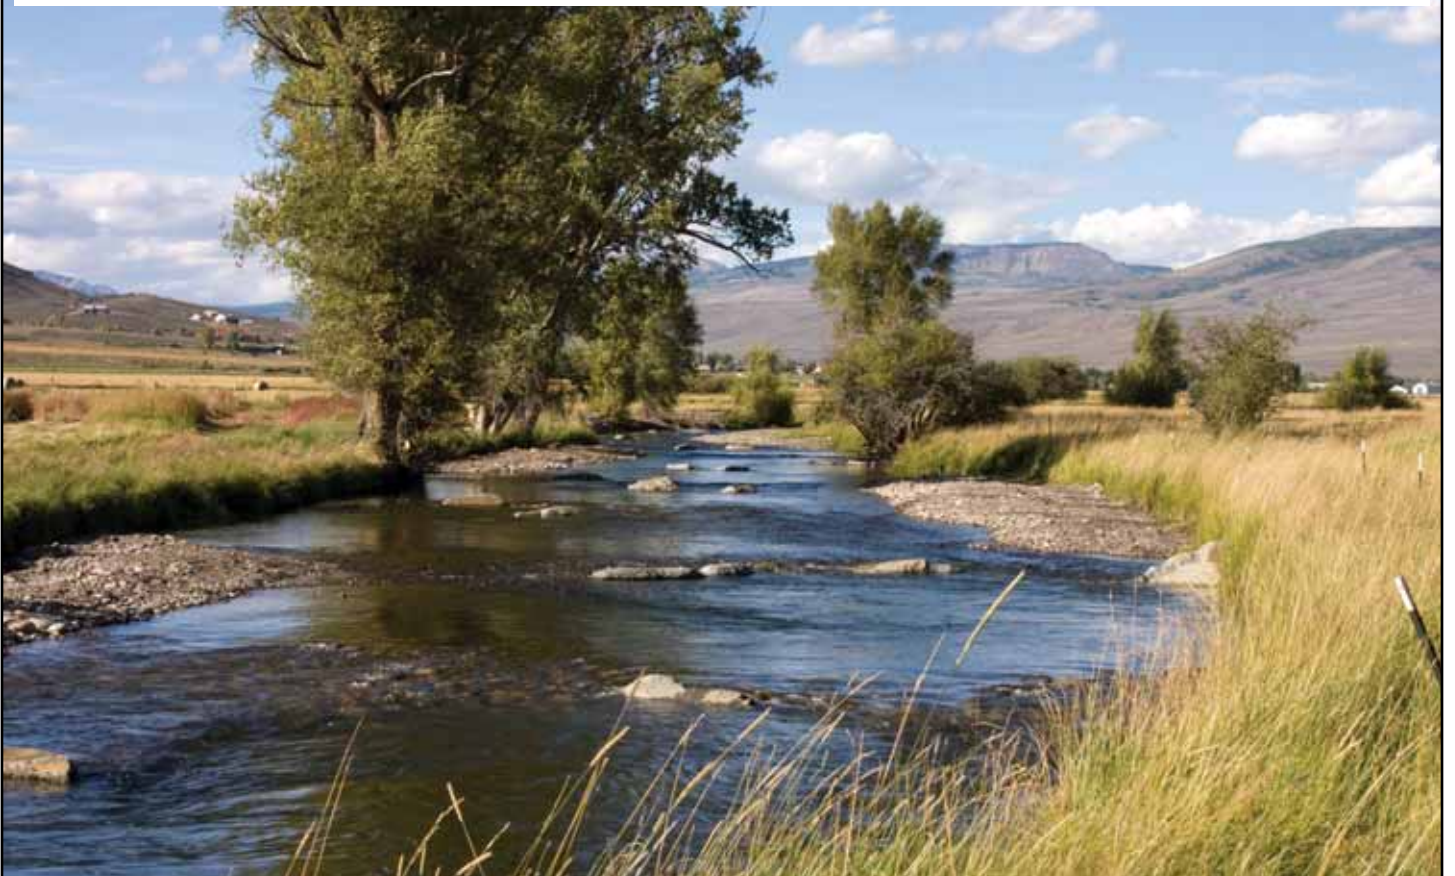
Before and after shot of Ohio Creek. Notice how featureless the creek is in top photo. After shot below shows how sinuosity has been restored, appropriate bars created, thalweg created, structures created, banks protected, etc.

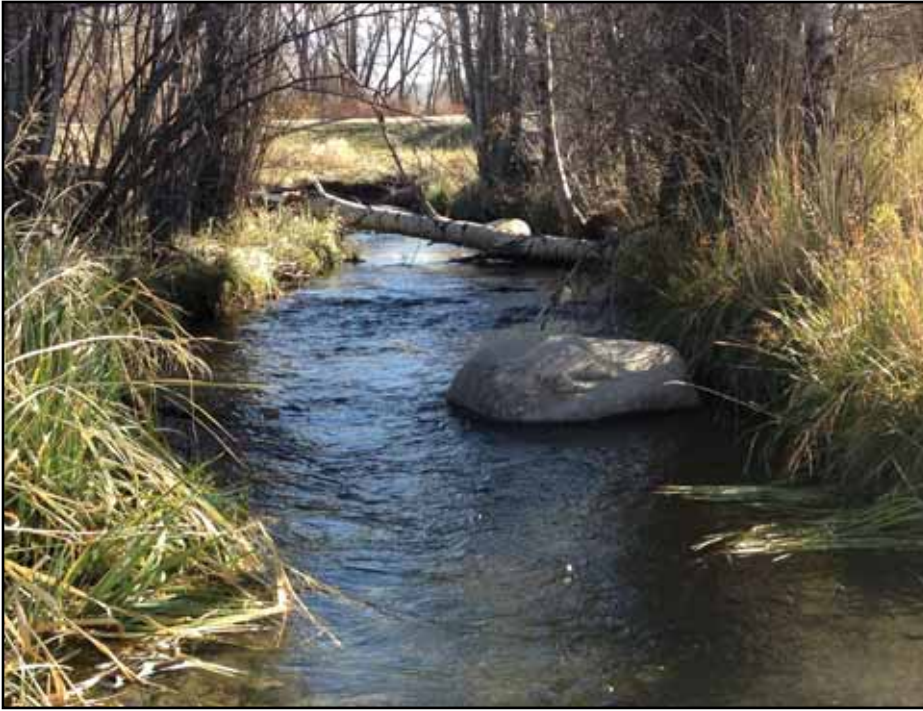
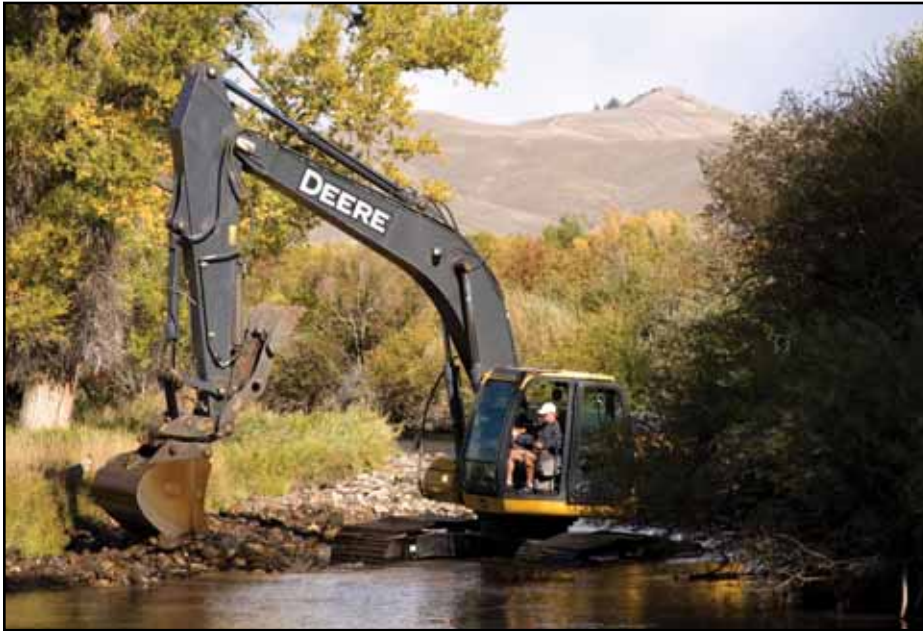
Top: Spring creek as it transitions through a slightly steeper section flanked by willows and cottonwoods. Below: Pulling some of the stream into a designed riffle area and point bar. This area was without a thalweg or suitable fish habitats.
